# PROJECTION HEADLIGHT

Item # 35779, 35780, 35781, 35782

## Normal Fogging / Condensation

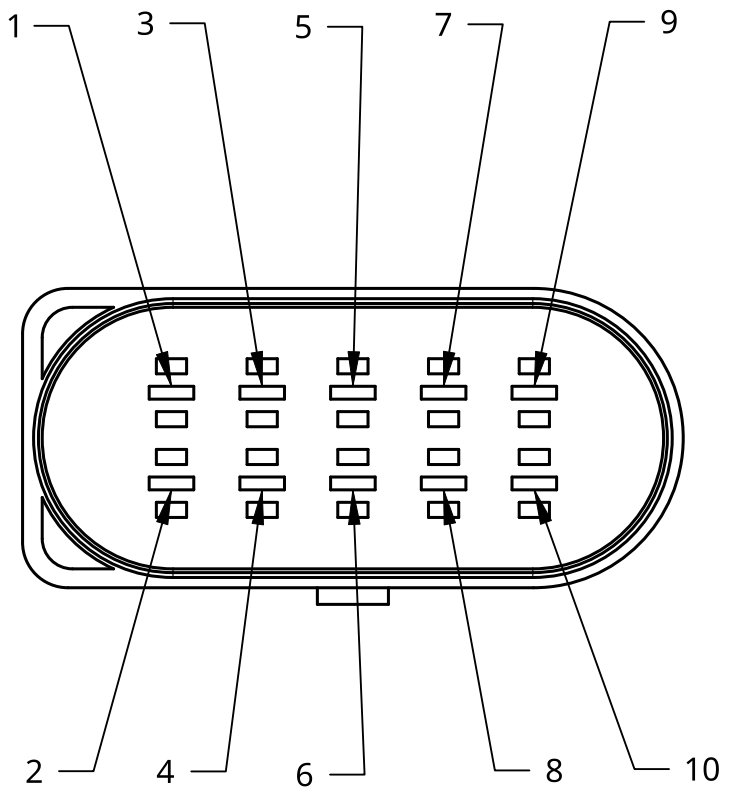
Pin#	Function
1	High Beam (+)
2	Turn Signal (+)
3	Parking (+)
4	Turn Signal (+)
5	Parking (+)
6	Ground (-)
7	Low Beam (+)
8	Low Beam (-)
9	DRL (+)
10	Not Used
